SURGICAL FACTORS FOR ESTABLISHING CRESTAL BONE STABILITY

IMPLANT DESIGN FACTORS

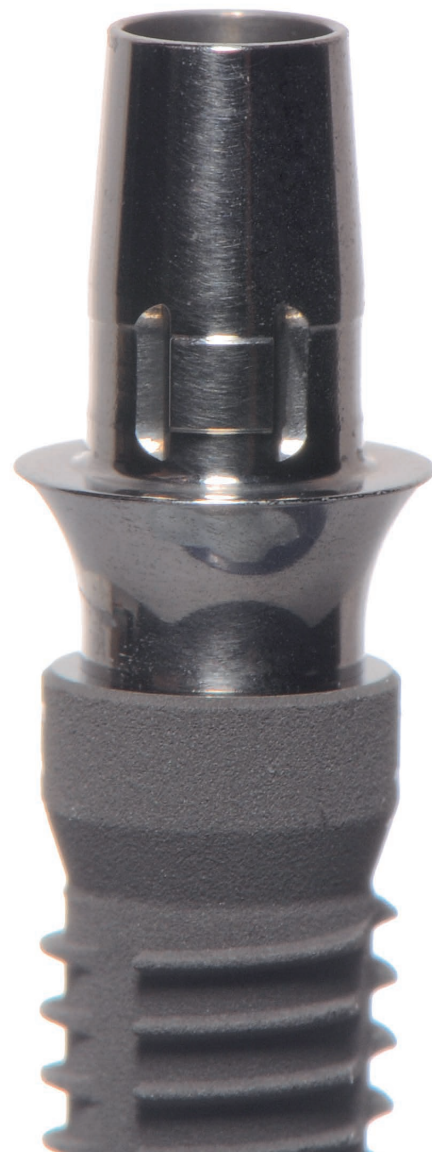
Fig 2-1 Different implant designs with different sizes of polished collars and types of implant-abutment connections. (a) Internal 45-degree connection (BioHorizons). (b) Conical connection with horizontal polished portion (Conelog). (c) Implant with a 12-degree conical connection (MIS). (d) Implant with a polished neck (Camlog).

So the depth of every implant strictly depends on its design factors combined with the level of knowledge of the clinician who places it. Differences in design begin with the implant neck and the implant-abutment connection (Fig 2-1). The next questions to ask are the following: Do these implant designs differ in effectiveness? What will be their influence on crestal bone stability immediately and over time?

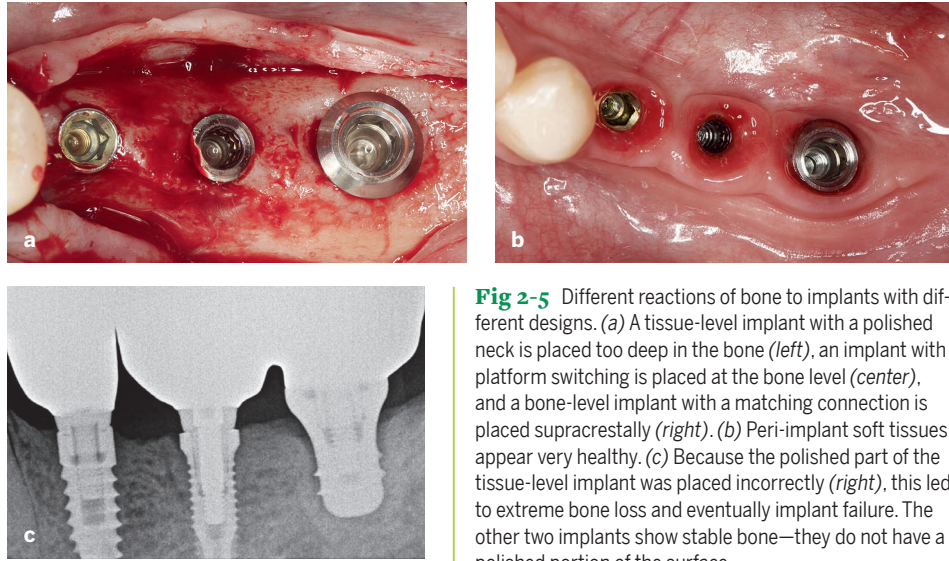
Fig 2-5 Different reactions of bone to implants with different designs. (a) A tissue-level implant with a polished neck is placed too deep in the bone (*left*), an implant with platform switching is placed at the bone level (*center*), and a bone-level implant with a matching connection is placed supracrestally (*right*). (b) Peri-implant soft tissues appear very healthy. (c) Because the polished part of the tissue-level implant was placed incorrectly (*right*), this led to extreme bone loss and eventually implant failure. The other two implants show stable bone—they do not have a polished portion of the surface.

not necessarily mean that the implant will be lost because of bone resorption around a polished neck, but this resorption is still worth avoiding whenever possible. Furthermore, it was reported that tissue-level implants, which usually have polished areas ranging from 1.8 to 2.8 mm, had only 1.5% early implant failures prior to loading and 2.0% late implant loss in a 9-year follow-up.¹² Therefore, it is recommended that the polished implant neck be positioned at the level of the bone, because if it is placed deeper, bone will eventually resorb to the smooth-rough surface border, regardless of the depth of implant placement (Figs 2-5 to 2-7).

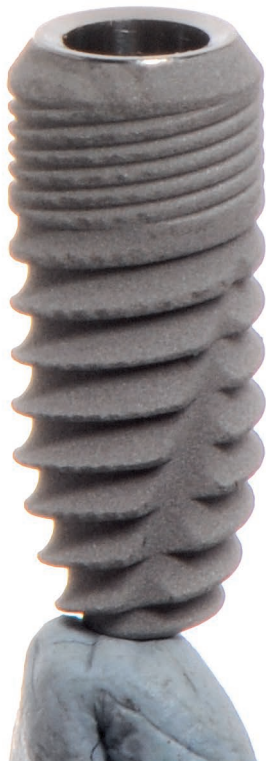
Fig 2-7 Some implants (eg, T6, NucleOSS) have a polished internal connection or are polished at the horizontal plane. This polished area is shielded from the bone and therefore poses no threat to bone stability.

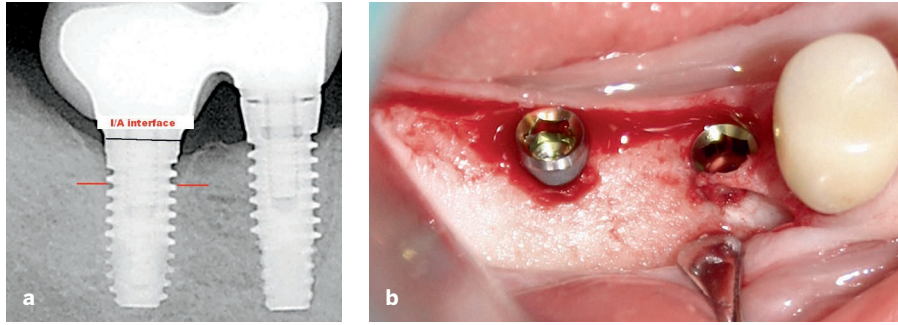
Fig 2-13 (a) Crestal bone loss around control (*left*) and test (*right*) implants. (b) Position of test implant (*left*) and control (*right*). The control implant was placed at the bone level, meaning that the microgap was located at the bone crest. After a 1-year follow-up, 1.68 mm of bone loss was registered around implants placed at the bone level, indicating that the microgap is an important factor in crestal bone stability. (Reprinted with permission from Linkevičius et al.²⁸)

bone if they are placed at bone level. Linkevičius et al²⁸ performed a controlled clinical study in which two implants with matching implant-abutment connections were placed adjacent to each other. The test implant was placed about 2 mm supracrestally, and a control implant was positioned at the crestal level. The placement of implants at bone level is a standard protocol that is recommended by a majority of manufacturers and studies. Prosthetic procedures with porcelain-fused-to-metal fixed restorations were initiated following a healing period of 2 months in the mandible and 4 months in the maxilla. Results showed that after 1 year of function, the control implants (ie, with the microgap placed at the bone level) experienced 1.68 mm of bone loss (Fig 2-13). If an implant is placed too deep in the bone, bone loss will occur after restoration even before 1 year of follow-up (Fig 2-14).

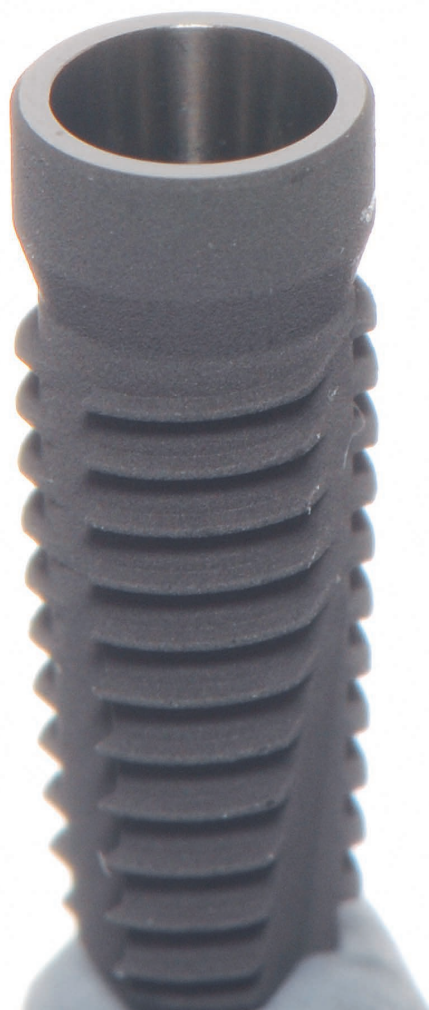
Fig 2-19 This implant with platform switching clearly demonstrates how the implant-abutment connection is moved toward the center. It is also important that the area of the horizontal shift is polished because this is where soft tissue ingrowth is expected.

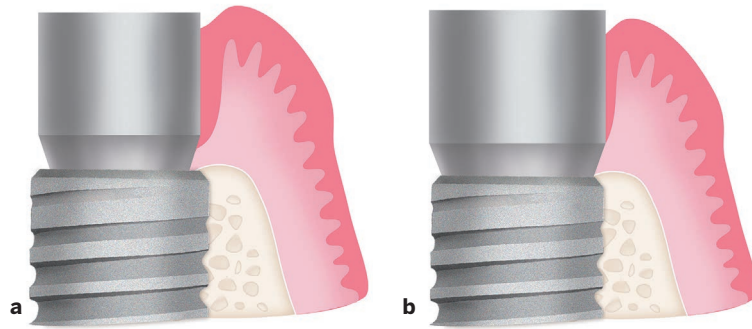
Fig 2-20 The size of the mismatch, ie, the extent of platform switching, is important for bone stability. An implant with a larger mismatch (a) will have less bone loss compared with an implant with less platform switching (b).

Many clinical studies have reported the positive impact of platform switching on crestal bone stability. The reduction in bone loss appears to be correlated with the size of the step between implant and abutment. In a prospective clinical study involving 69 implants in 31 patients, Canullo et al found bone loss of 1.49 mm at implants with matching abutments, 0.99 mm at implants with a 0.2-mm step, 0.82 mm with a 0.5-mm step, and 0.56 mm with a 0.85-mm step. Thus, the mean positive impact on bone resorption 33 months after implant surgery was greater when the step of platform switching was larger¹ (Fig 2-20).

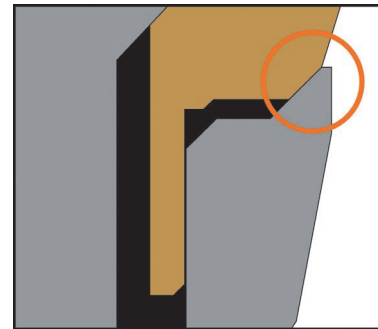
Fig 2-21 Internal connection showing a closed biologic seal at the outer level (circle).

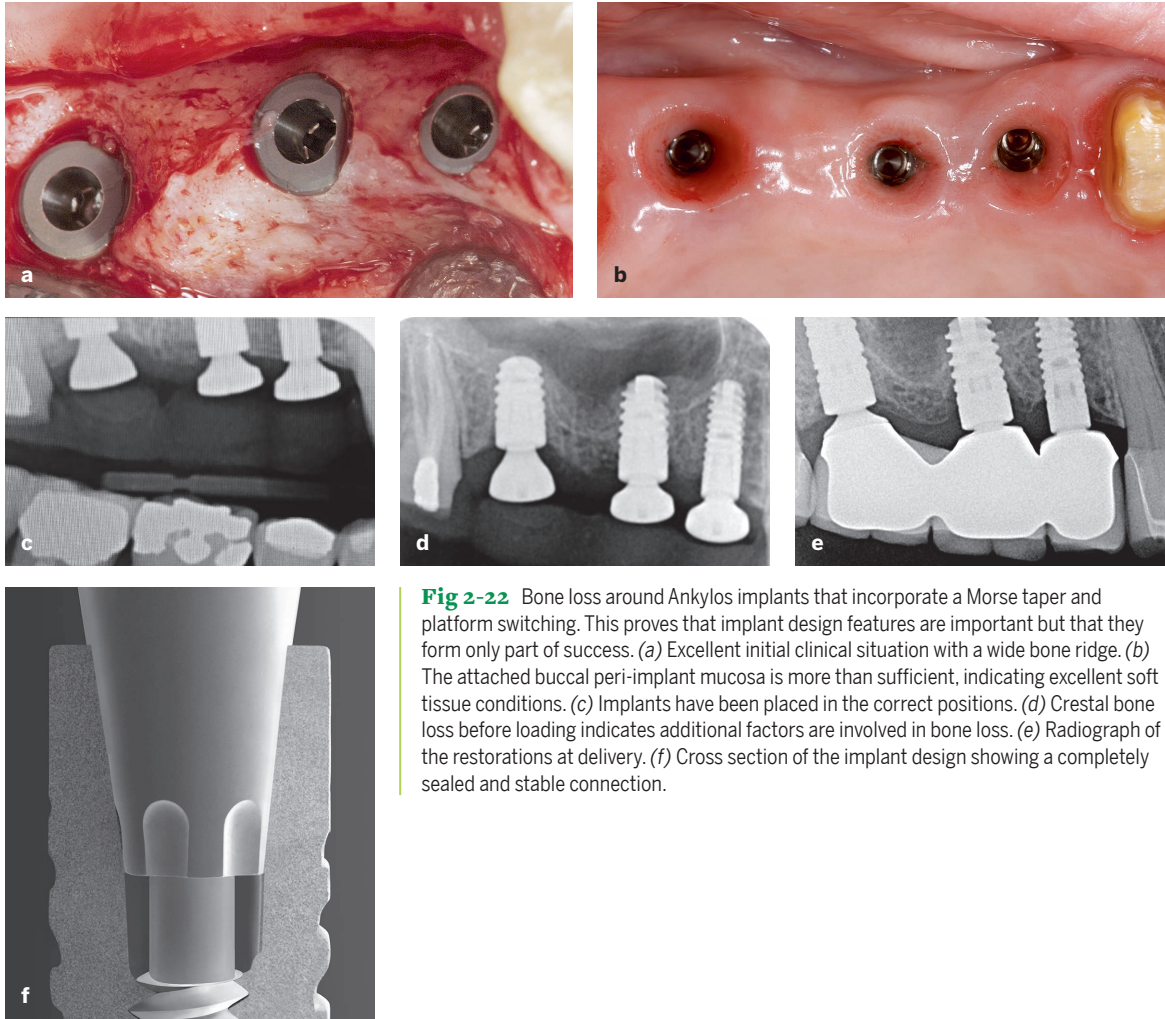
Fig 2-22 Bone loss around Ankylos implants that incorporate a Morse taper and platform switching. This proves that implant design features are important but that they form only part of success. (a) Excellent initial clinical situation with a wide bone ridge. (b) The attached buccal peri-implant mucosa is more than sufficient, indicating excellent soft tissue conditions. (c) Implants have been placed in the correct positions. (d) Crestal bone loss before loading indicates additional factors are involved in bone loss. (e) Radiograph of the restorations at delivery. (f) Cross section of the implant design showing a completely sealed and stable connection.
